Manhole Inspection Summary

Manhole # S25I__044MH

Location Address: **Behind 1107 W.Lombard St.**

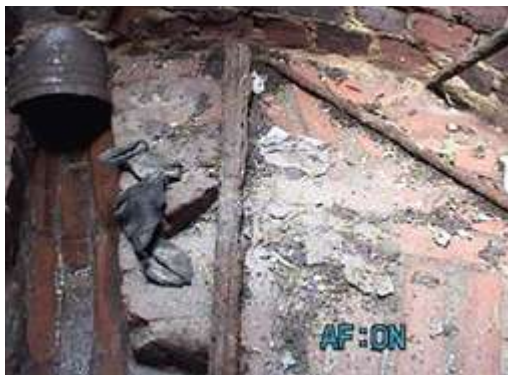
Defect 6

debris on bench

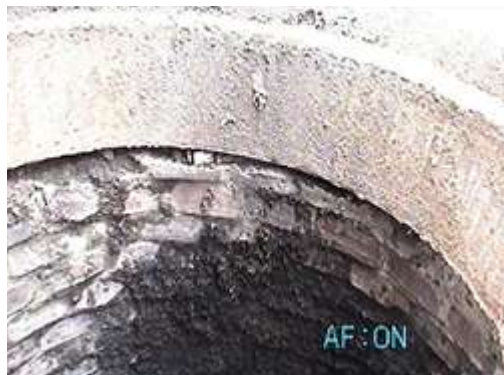
Defect 5

Condition: ☐ Sound ☐ Cracked ☐ Root Intrusion ☒ **Loose Brick** ☐ Deteriorated

Infiltration: ☐ None ☐ Joint ☐ Cracks ☒ **Mortar** ☐ Roots ☐ Wall

chimney loose bricks, signs of flow at mortar

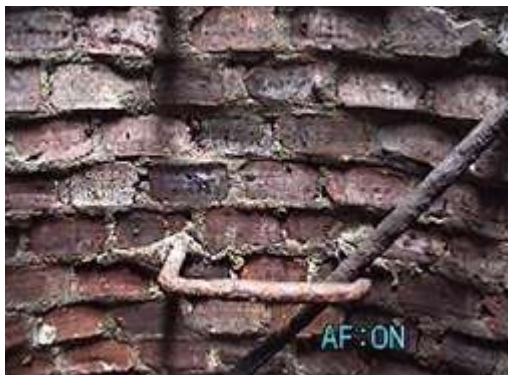
Defect 2

Count: **4** Missing: **0** ☒ **Corroded**

corroded rungs

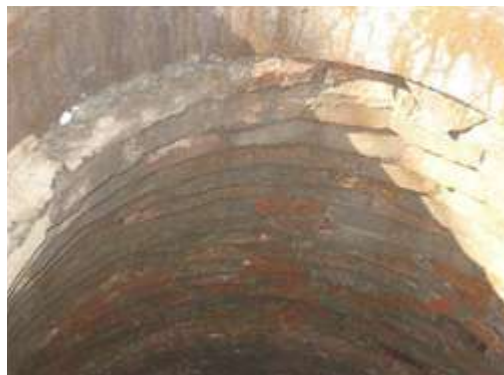
Defect 1

Offset: **2** (in.)

Condition: ☐ Sound ☐ Cracked ☒ **Leaks**

frame offset 2"

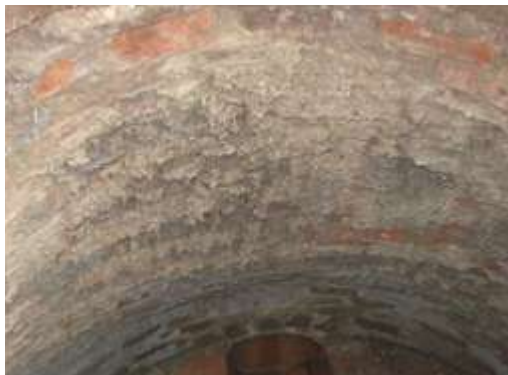
Infiltration: ☐ None ☐ Joint ☐ Cracks ☐ Mortar ☐ Roots ☒ **Wall**

mud deposits in corbel & barrel walls,
signs of infiltration

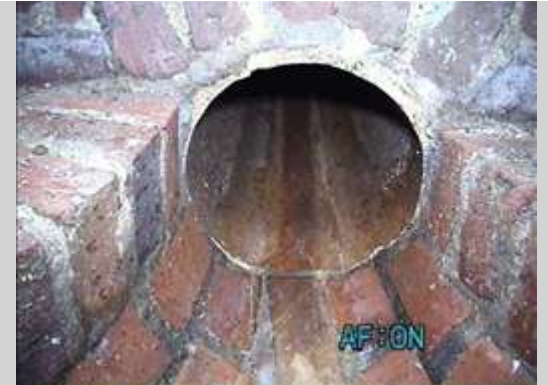
12 O'Clock Outflow

Pipe Height: **8.4** (in.) Rod and Bar (Angled)
Pipe Material: **Clay** ☐ Pipe Lined
Invert Depth: **7.27** (ft.) Flow Characteristics: **None**
Deposits: ☒ None ☐ Mud ☐ Sludge ☐ Debris ☐ Grease
Silt Depth: **0** (in.) Deposits Extent:
Infiltration: **None** Pipe Seal Cond: **Sound**

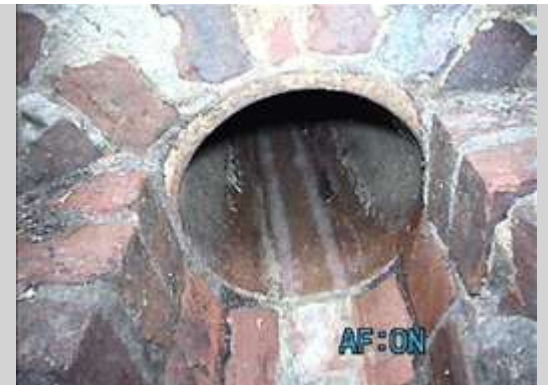
3 O'Clock Inflow

Pipe Height: **8.4** (in.) Rod and Bar (Angled)
Pipe Material: **Clay** ☐ Pipe Lined
Invert Depth: **7.13** (ft.) Flow Characteristics: **None**
Deposits: ☒ None ☐ Mud ☐ Sludge ☐ Debris ☐ Grease
Silt Depth: **0** (in.) Deposits Extent:
Infiltration: **None** Pipe Seal Cond: **Sound**

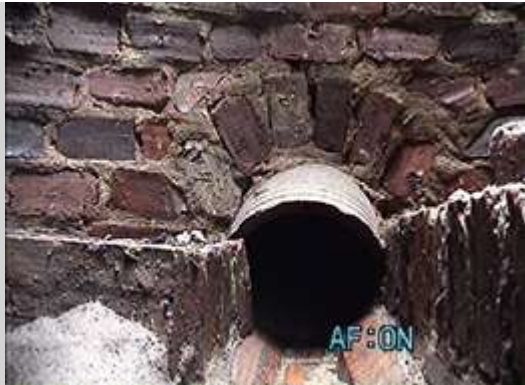
5 O'Clock Inflow

Pipe Height: **6** (in.) Rod and Bar (Angled)

Pipe Material: **Unknown** ☐ Pipe Lined

Infiltration: **None**

Pipe Seal Cond: **Sound**

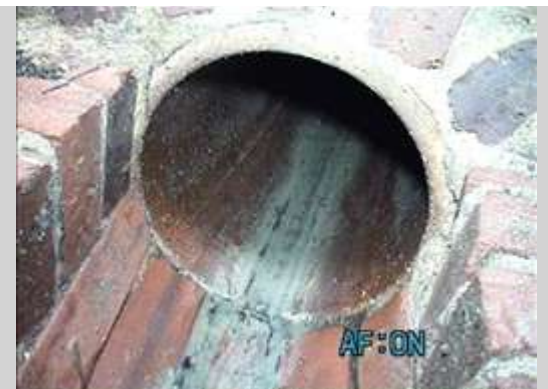
8 O'Clock Inflow

Pipe Height: **8.4** (in.) Rod and Bar (Angled)

Pipe Material: **Clay** ☐ Pipe Lined

Infiltration: **None**

Pipe Seal Cond: **Sound**
